EARTHQUAKE DAMAGE REPAIR AND STRENGTHENING OF CHRIST CHURCH CATHEDRAL, NEWCASTLE NSW

B.J. Collins BScArch, BArch,
MSc(Arch)(Cons), ARAIA
EJE Architecture Pty Ltd
Chartered Architects
412 King Street
Newcastle NSW Australia

J.W. Jordan BE, FIEAust, CPEng
Bill Jordan & Associates Pty Ltd
Structural Engineer & Heritage
Consultant
40 Tyrrell Street
Newcastle NSW Australia

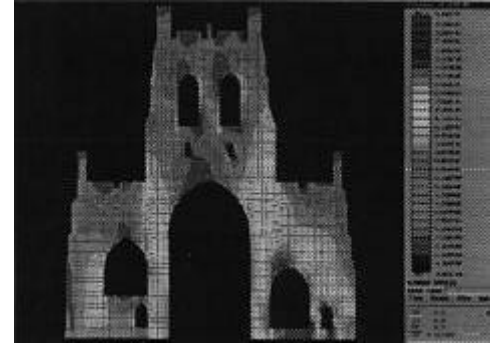
Figure 13: Typical FEA output

With the design parameters set (see Appendix) a two-dimensional finite element analysis was carried out using a readily available computer package ("Strand 6"). Different combinations of reinforcement strength and spacing were considered and costed and, in the end, a high strength Grade 316 stainless steel deformed bar was used in sizes from 16 mm to 32 mm diameter. In order to limit the amount of drilling that had to be carried out "Hi-Proof" bar with UTS in range 790 to 920 MPa [N/mm²], depending on size, was specified. The total length of reinforcing installed was 3770 metres.

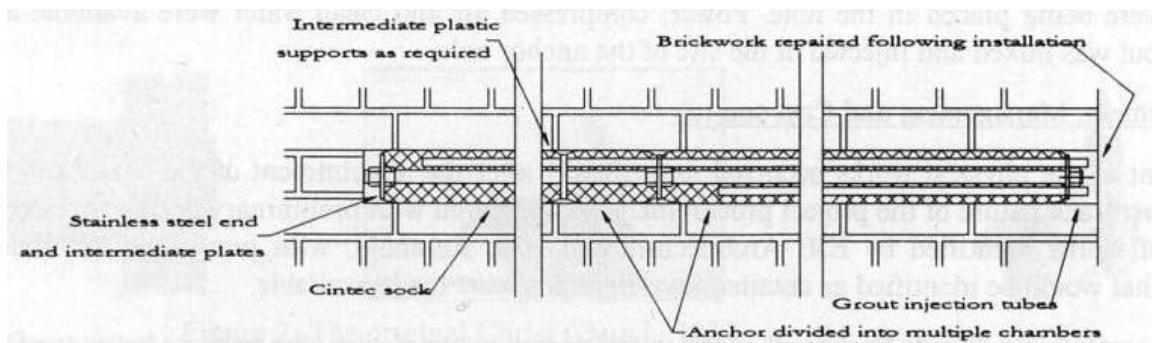
Figure 14: Typical anchor using 25 mm deformed bar in 85 mm diameter hole

The Cintec anchor system has three basic elements: the anchor body which carries the load, the cementitious grout formulated using micro-cement technology and the woven fabric sock which controls the grout. Details of the sock and grout can be found in company literature (Cavity Lock Systems Ltd, current).

The sock design for the Cintec system allows the sock to expand in the drilled hole, and to its maximum in voids, without the openings in the weave allowing more than the finest fraction of grout to pass through. This "grout milk" contains the inorganic adhesion agents of the grout together with the excess moisture not required for cement hydration. The final expulsion of the excess moisture does not occur until the full sock is pressurized, when the inflated sock becomes hard. This process ensures that the filling of the sock can be monitored by observing a small section, either at the injection end or by way of a small observation hole for remote chambers. For shorter anchors, the Cintec system uses return grout tubes for the monitoring of blind chamber inflation. This was not possible for most of the very long holes on the Cathedral without an increase in hole size, but small monitoring holes at joints could be drilled to the side of anchors and repaired later.

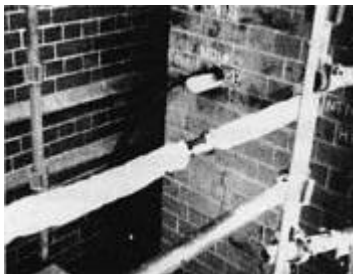
Figure 15: Horizontal anchors assembled during installation

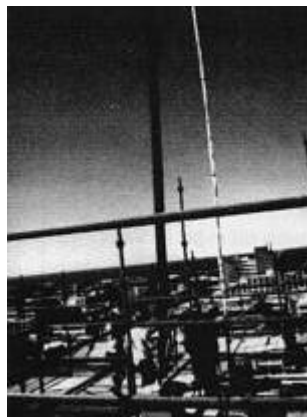
Figure 16: Vertical anchor installation by crane

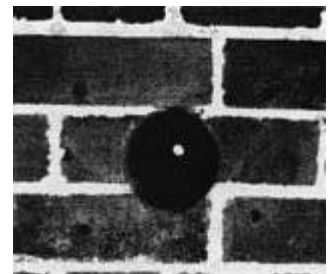
Figure 17: Finished installation and brickwork repair

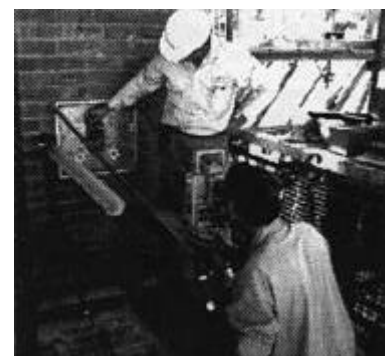
Figure 18: Drill hole survey
