EARTHQUAKE DAMAGE REPAIR AND STRENGTHENING OF CHRIST CHURCH CATHEDRAL, NEWCASTLE NSW

B.J. Collins BScArch, BArch,
MSc(Arch)(Cons), ARAIA
EJE Architecture Pty Ltd
Chartered Architects
412 King Street
Newcastle NSW Australia

J.W. Jordan BE, FIEAust, CPEng
Bill Jordan & Associates Pty Ltd
Structural Engineer & Heritage
Consultant
40 Tyrrell Street
Newcastle NSW Australia

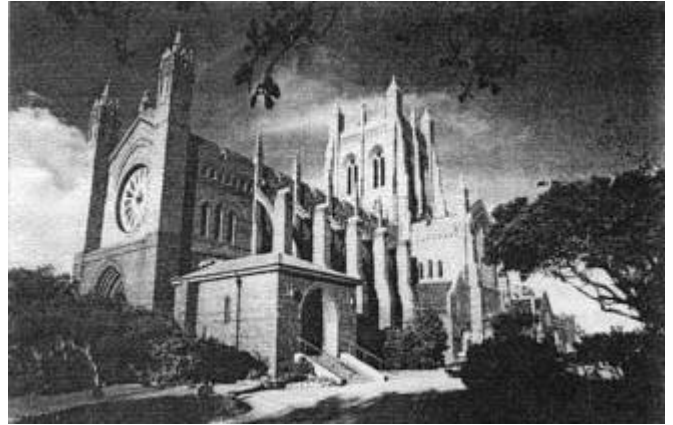
The effect of the earthquake on the building was largely as would be expected: high-set stone crosses and other decorations were dislodged and fell to the ground or lower roofs; flying buttresses were dislodged, but none fell completely away; shear cracking occurred in the nave walls which lie roughly parallel to the direction of the seismic wave and out-of-plane movements occurred in the east wall and dislodged windows. The degree of damage varied with the state of the brickwork with very little occurring in the tower structure, completed in 1979.

**Figure 1: Christ Church Cathedral, Newcastle, Austral
1989**
